Experimental and analytical investigation of dynamic crack patterns in automotive windshield sheets subjected to low velocity impact

Abstract

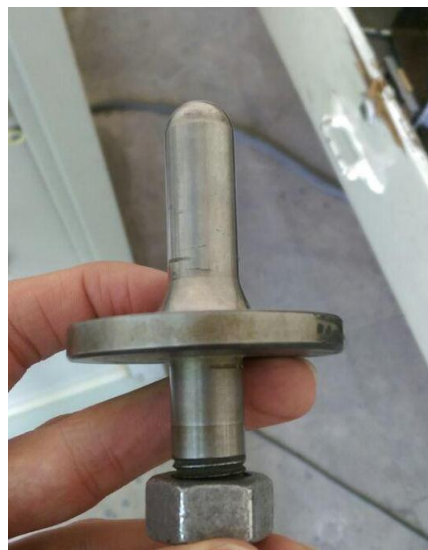
Fig2. Steel imp actor used in drop ball tests

The geometrical and mechanical properties of the impactor (which is depicted in Fig.2) are explained in Table 2.

Geometrical properties	Mechanical properties
Spherical part: Diameter= 16mm	Material: steel
Cylindrical part: Height 45mm	E= 200GPa, $\mu=0.3$

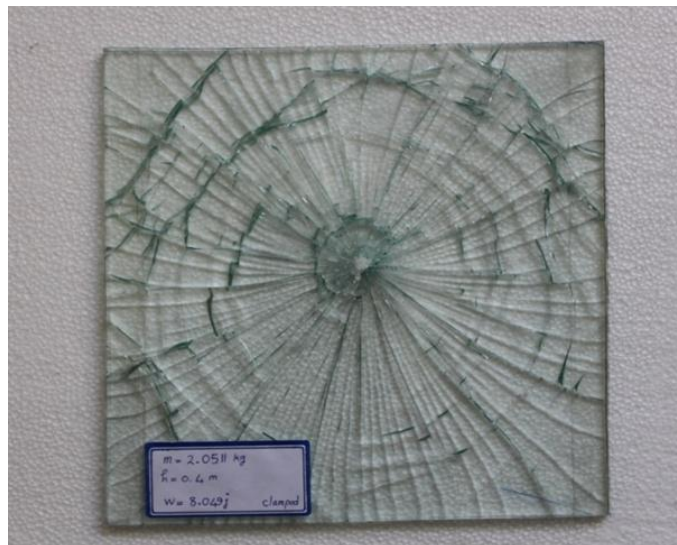
Fig10. .specimen after test code D-B-T-4

Laminated glass specimen after test code D-B-T-4 is shown in Fig.10.

As it is observed from Fig.10, the impact region at the center of specimen (powdering region) is a circle with approximate diameter of 20mm in which cracks density and consequently damage level is higher than the other regions of specimen. The projectile has penetrated to the depth of 1-1.5mm of the laminated glass and due to 2.5mm thickness of glass layers, no elongation has been occurred in PVB interlayer. Although energy level of test code D-B-T-4 is higher than test code D-B-T-3's one, penetration at the center of specimen is less in test code D-B-T-4 which

can be representative of impactor's mass influence. In test code D-B-T-4, the impactor mass is 2.0511kg, while it is 2.0712kg in test code D-B-T-3, therefore it can be concluded that in 2 similar conditions, the less impactor mass, the less penetration depth at the center of specimen.

It is easily seen from test code D-B-T-4 specimen that cracks have initiated from the impact surface and propagated through thickness. In this test, one circumferential crack has been propagated which is at the radius of 95mm from the center. Besides, some sectors of circumferential cracks have been made at the

radiuses of 62, 70 and 80mm from the center of specimen and serve as bridges to connect radial cracks. Also it can be seen from the laminated glass that the radial cracks in test code D-B-T-4 are nearly symmetrical and about 84. After drawing a comparison between test code D-B-T-4 and test code D-B-T-3, it is obvious that radial cracks of test code D-B-T-4 are more than their counterparts in test code test code D-B-T-3, on the other hand circumferential cracks of test code D-B-T-3 are more than test code D-B-T-3's ones. At test code D-B-T-4, distance between radial cracks is shorter than its corresponding item in test code D-B-T-3.

At all 4 sides of specimen which was clamped during the test, diagonal asymmetrical

net shaped cracks have been made which have created some right triangles in margins of the specimen. Diagonal net shaped cracks at the margins of test code D-B-T-4 specimen are more congested in comparison to the whole radial cracks. In addition, at both upper and lower glass layers, radial cracks converge at the center of the specimen and their divergence increases at larger radiuses. The acceleration versus time graph of test code D-B-T-3 is illustrated in Fig.11. As it can be seen from the graph, the maximum acceleration imposed to projectile is 732.0356m/s^2 which is occurred at 0.000131s .

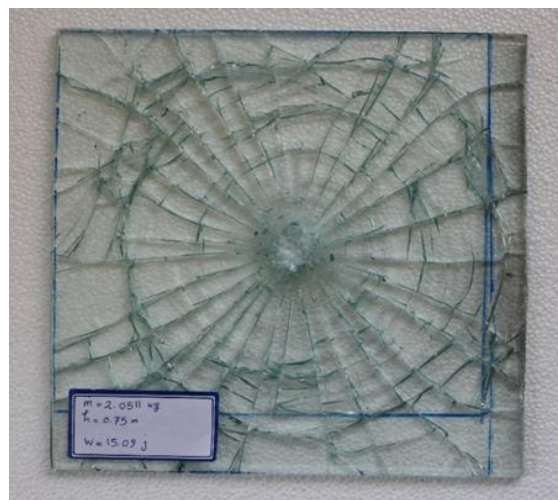
Fig12. .specimen after test code D-B-T-5

Laminated glass specimen after test code D-B-T-5 is shown in Fig.12.

As it is observed from Fig.12, the impact region at the center of specimen (powdering region) is a circle with approximate diameter of 20mm in which cracks density and consequently damage level is higher than the other regions of specimen. The projectile has penetrated to the depth of 4mm of the laminated glass, indeed the upper layer glass has fractured and PVB interlayer has elongated, but no tearing is observed. At the center of test code D-B-T-5 laminated glass, penetration depth has increased in comparison to test codes D-B-T-4 and D-B-T-3. Total number of circumferential cracks of the specimen is 5 which are placed at 47, 70, 80, 90 and 105mm distance from the center. At the vicinity of borders (close to clamping spots), net shaped diagonal cracks are more congested. Cracks have been propagated from the impact surface of laminated glass. At all 4 sides of the specimen, diagonal asymmetrical net shaped cracks have been made. At both upper and lower glass layers, radial cracks converge at the center of the specimen and their divergence increases at larger radiuses. Most of radial cracks have reached the borders of specimen and released their internal impact energy by this way.
