Study of the effect on manufacturing parameters on the fatigue behavior of aluminum engine mounting bracket

Hossein Khalajzadeh¹, Seyed Vahid Hosseini^{*1}, Alireza Shaterzadeh¹

¹Faculty of Mechanical Engineering, Shahrood University of Technology, Shahrood, Iran.

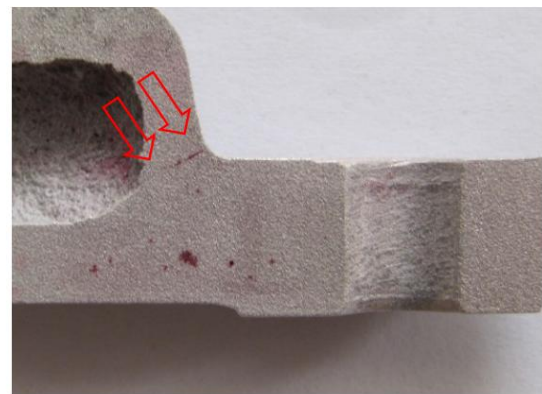
According to the ASTM E155 standard, after the machining of the part, the presence of holes up to 6 holes in the part with a maximum distance of 10 mm and a maximum depth of 2 mm cannot be the reason for failure in the part. As it is clear in Figure 6, it was observed that the crack did not occur in the connection area of the base to the wall due to the presence of a hole in this area.

Figure 6. Crack in the inner area of the connection of the base to the wall.

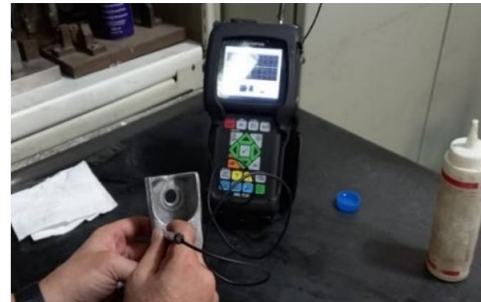
Figure 8. a) Ultrasonic thickness measurement. b) The graph obtained from the thickness measurement results of the prototype. c) Location of point 16 (Minimum thickness).
